The Islamabad Marriott in Flames: The Attack on the World's Most Protected Hotel

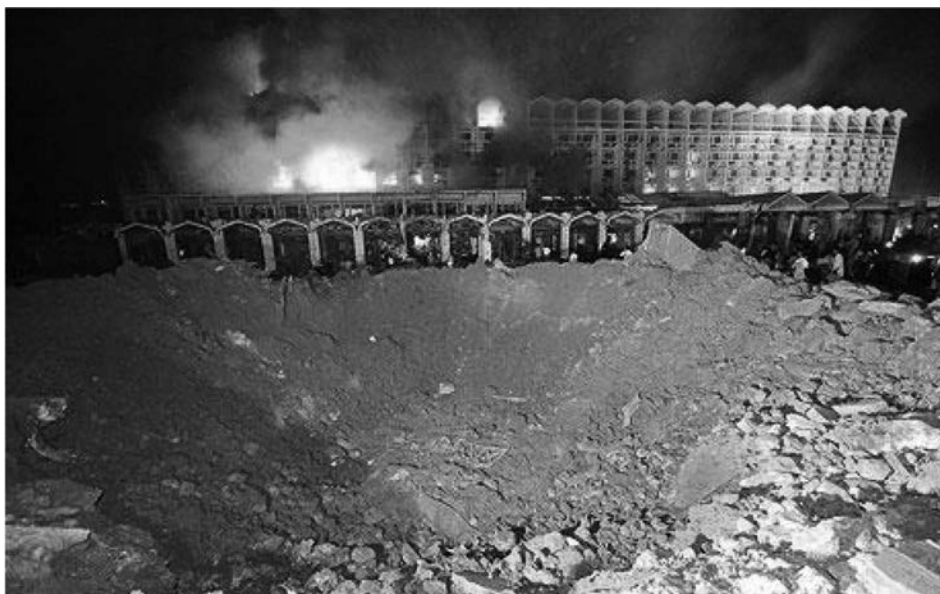
Bomb crater at the Marriott Hotel (Darwar, 2008)

The explosion could be heard 18 miles (30 kilometres) away, created a deep crater 59 feet by 25 feet (18 m by 7.6 m) and ignited a fire that burnt for two days.

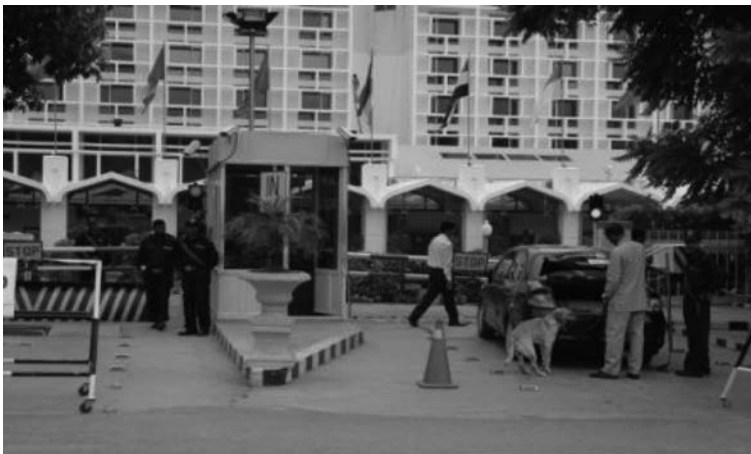
Security measures at the Marriott Hotel entrance before the attack

Over the years, the hotel enhanced its security. The hotel security personnel stationed on both sides of the entrance to the property were armed with shotguns. The security supervisors were armed with handguns. New bollards had been placed alongside the street – pushing the standoff further out. There were plain-clothes security personnel conducting surveillance detection. There was an officer from the Special

Prior to the attack, the security consisted of 62 CCTV cameras that are always monitored by three security officers. The hotel placed window film on glass in all public areas to provide fragment retention in the event of explosions. In March 2008, the vehicle inspection area was enhanced. Included in that security enhancement was a combination of a drop-down barrier and hydraulic barriers. It had under-vehicle cameras that sent pictures to a monitor in the security booth. These cameras also recorded on stand-alone CCTV in the security booth. Additional cameras recorded the licence plates of vehicles.

Physical security of the gates began with a single trolley barrier at each gate. This small barrier on wheels indicated to drivers that a security checkpoint was ahead and he ought to slow down. In normal circumstances, when the car slows down, the security guard wheels the trolley barrier to one side. The car then moves slowly up to the hydraulic barrier in a position adjacent to the security booth. While the guard who wheels the trolley barrier then opens the trunk (boot) of the car, another guard inside the booth screens the underside of the car with the fixed underside CCTV camera. Another guard speaks to the driver and looks into the inside of the vehicle. If the vehicle is deemed to have passed all inspection, the guard inside the booth will operate the hydraulic barrier to lower. Directly in front of the hydraulic barrier is a heavy-duty arm gate barrier – as the hydraulic barrier lowers the arm gate barrier is raised manually via a rope. As the vehicle clears the arm gate barrier, the hydraulic barrier rises and the trolley barrier is rolled back into place.

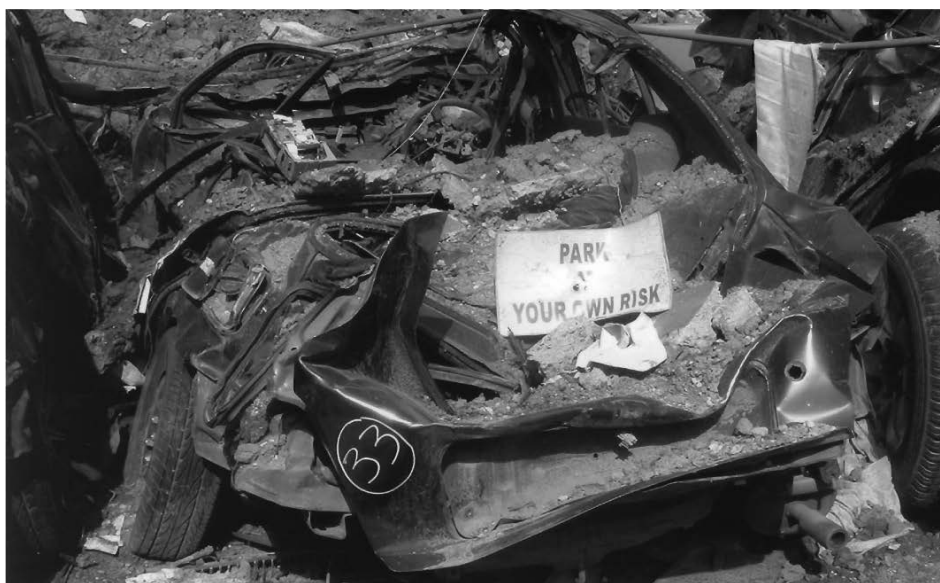
The hotel car park sign says it all

between the gate and the front of the hotel mitigated the effects of the blast. Had the gate not stalled the truck from gaining access to the hotel compound, the devastation would have been manifold.

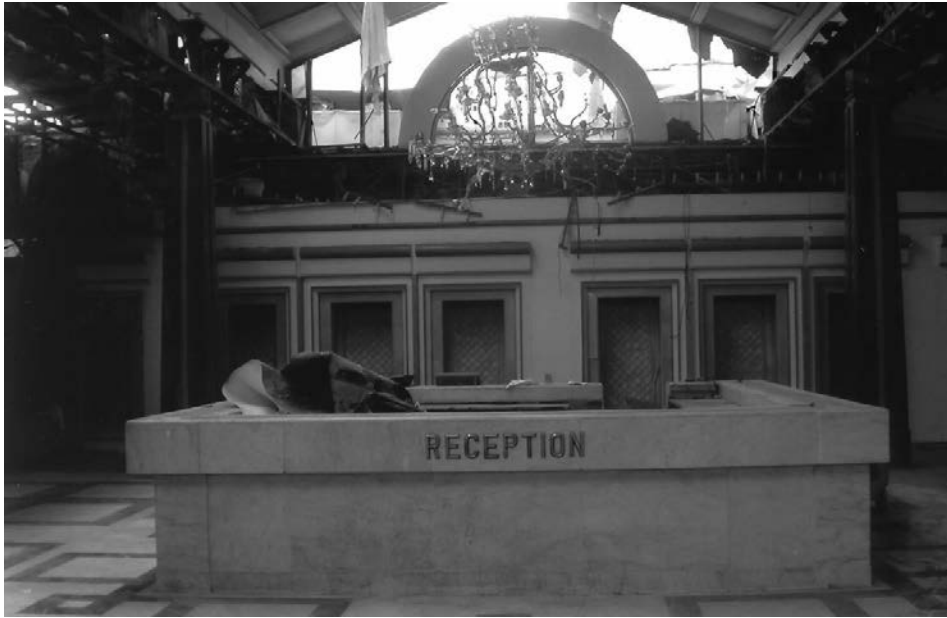
The hotel lobby post-attack
